**Flood Control Project Maintenance
Levee Inspections**

Fall 2010 Levee Maintenance Deficiency Summary Report

Sacramento River Basin

Reclamation District No. 0554 Walnut Grove

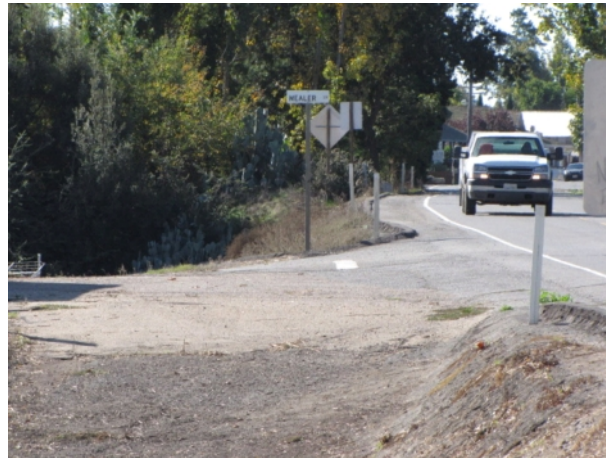
Levee Mile Report Line	1
Start Levee Mile	0.00
End Levee Mile	0.00
Location	Land Side
Category	Earthen Levee
Item	Vegetation

Looking downstream from levee mile 0.00 of RD 554 landside. Photo taken 11-09-2010

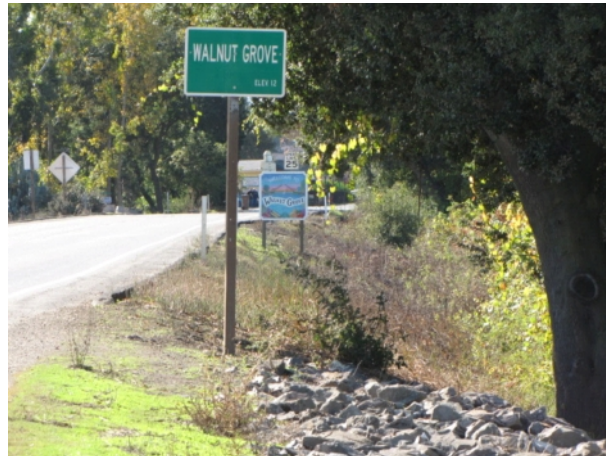
Levee Mile Report Line	2
Start Levee Mile	0.00
End Levee Mile	0.00
Location	Water Side
Category	Earthen Levee
Item	Vegetation

Looking downstream from levee mile 0.00 water side of RD 554. Photo taken 11-09-2010

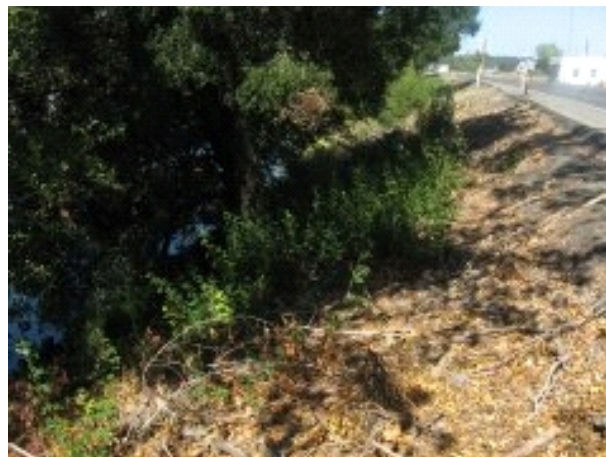
Levee Mile Report Line	3
Start Levee Mile	0.25
End Levee Mile	0.34
Location	Water Side
Category	Supplemental
Item	USACE Erosion Survey

2009: 2 ft berm, 1.5:1 slope, tension cracks, tree hazards, holes and slumping, clays and silts, 6.23 ft/s [2009 SiteID:SAC_27-0_L]

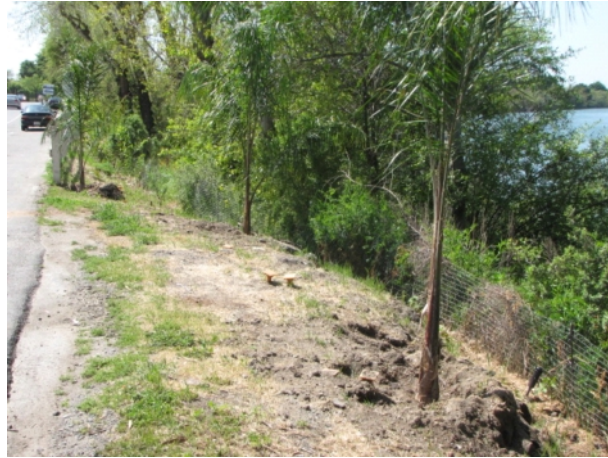
Levee Mile Report Line	8
Start Levee Mile	0.69
End Levee Mile	0.69
Location	Water Side
Category	Earthen Levee
Item	Encroachments

This photo shows the unauthorized trees planted on water ward shoulders. 38.240735-121.515137 levee mile 0.69 facing downstream standing on water side.

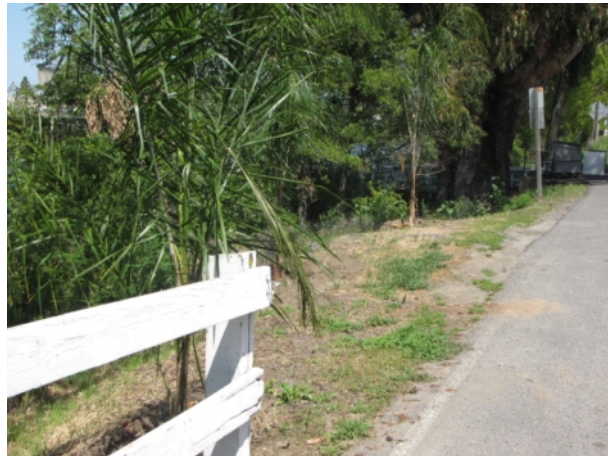
Levee Mile Report Line	8
Start Levee Mile	0.69
End Levee Mile	0.69
Location	Water Side
Category	Earthen Levee
Item	Encroachments

Standing downstream on waterside looking upstream at unauthorized planting of trees on shoulder.
